TITLE OF THESIS/*TITRE DE LA THÈSE* INTERACTION OF CONCRETE MASONRY BEARING WALLS AND CONCRETE FLOOR SLABS

UNIVERSITY/*UNIVERSITÉ* UNIVERSITY OF ALBERTA

DEGREE FOR WHICH THESIS WAS PRESENTED/ *GRADE POUR LEQUEL CETTE THÈSE FUT PRÉSENTÉE* M. Sc.

YEAR THIS DEGREE CONFERRED/*ANNÉE D'OBTENTION DE CE GRADE* 1979

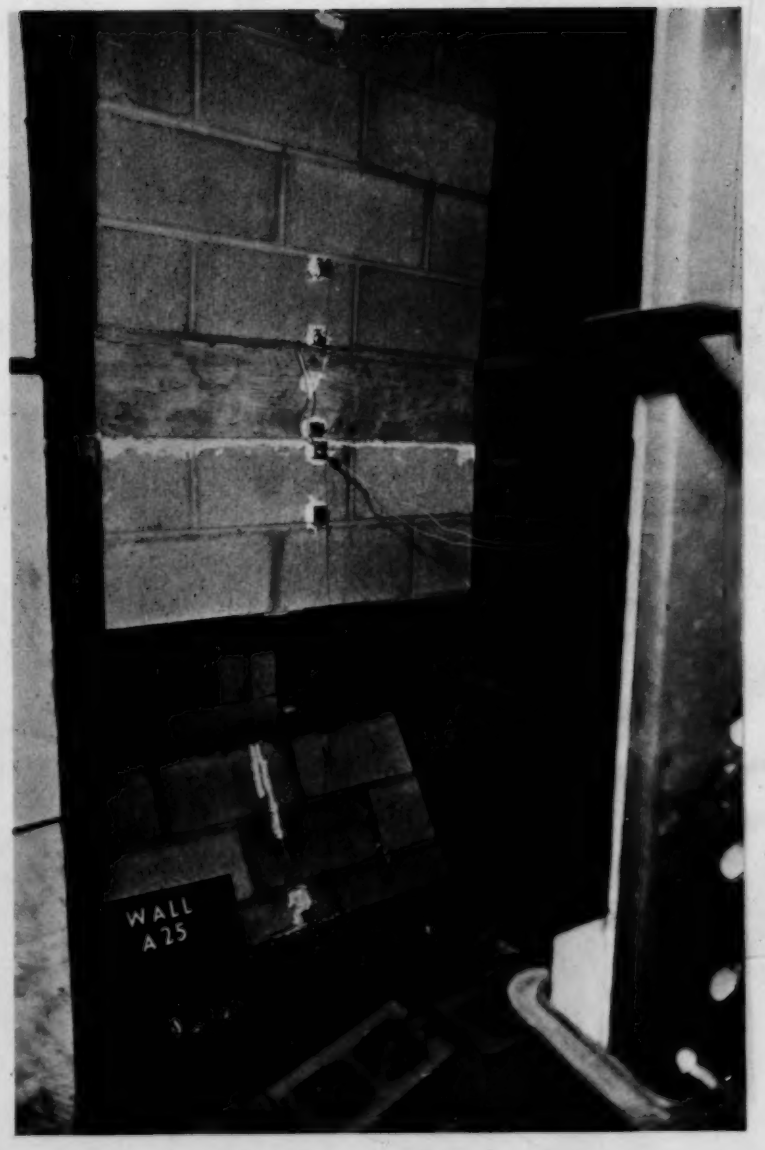
Plate 4.1 Wall A25 At Failure

A photograph of wall A25 at failure, a typical tension type failure, is presented in Plate 4.1. A photograph of wall A100 at failure, a typical compressive failure of an unreinforced wall, is presented in Plate 4.2 and a photograph of wall B150 at failure, a typical compressive failure of a reinforced wall, is presented in Plate 4.3.

As the slab was loaded a horizontal crack opened in the first mortar joint above the slab. This crack became increasingly larger until Mmax was reached, at which time the crack size increased significantly and the block above the slab assumed a rotation opposite to that of the slab. The slab deflection was next increased until a large crack appeared in the mortar joint 3 blocks below the slab, and finally the bottom half of the wall tipped over. The rotations of the blocks and slab end together with the corresponding moments are tabulated in Table 4.2 and the deflected shape of the wall is presented graphically in Fig. 4.3.

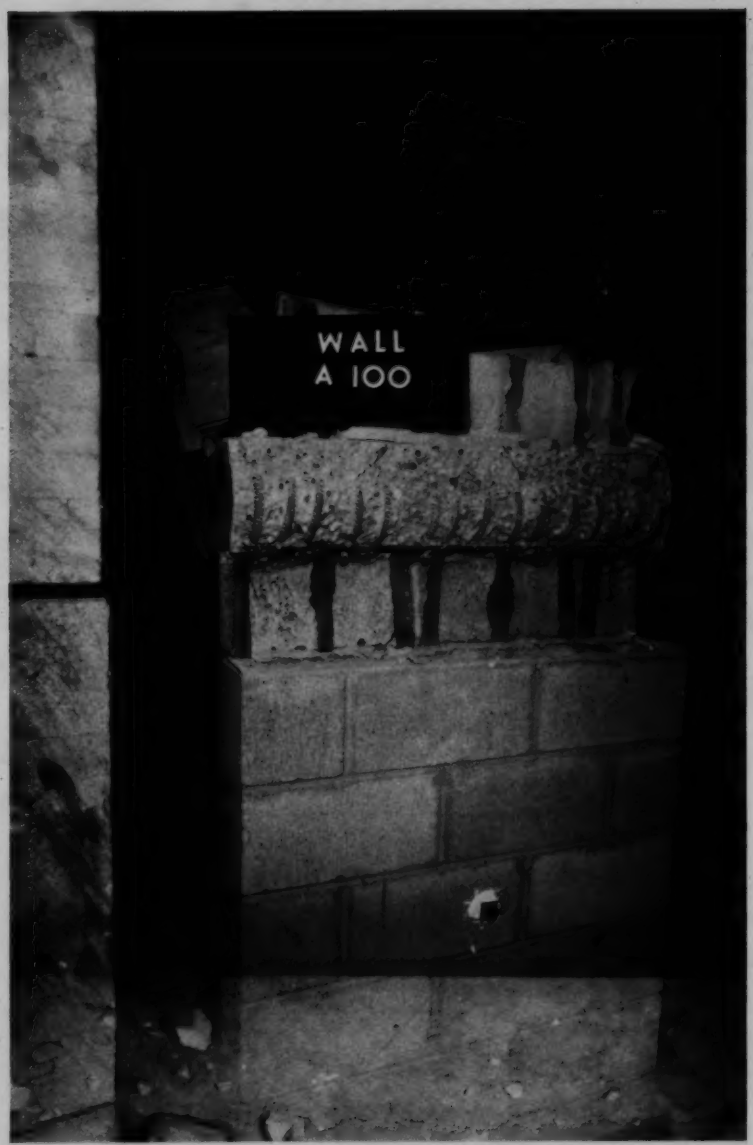
Plate 4.2 Wall A100 At Failure

Upon reaching Mmax the walls immediately failed. The unreinforced walls failed by vertical splitting of the upper wall extending from the slab to the top block. The reinforced walls failed by vertical splitting of only the block above the slab with the compression side of the block falling away from the specimen. For both the reinforced and unreinforced walls a large amount of concrete spalled from the slab.

No horizontal cracks were observed until Mmax was reached and the blocks in the upper wall split vertically. The blocks in the course below the slab also split and the concrete slab spalled off, at the end of the slab reinforcing bars. The rotations of the blocks and slab end with the corresponding moments are tabulated in Table 4.4 and the deflected shape of the wall is presented graphically in Fig. 4.5.

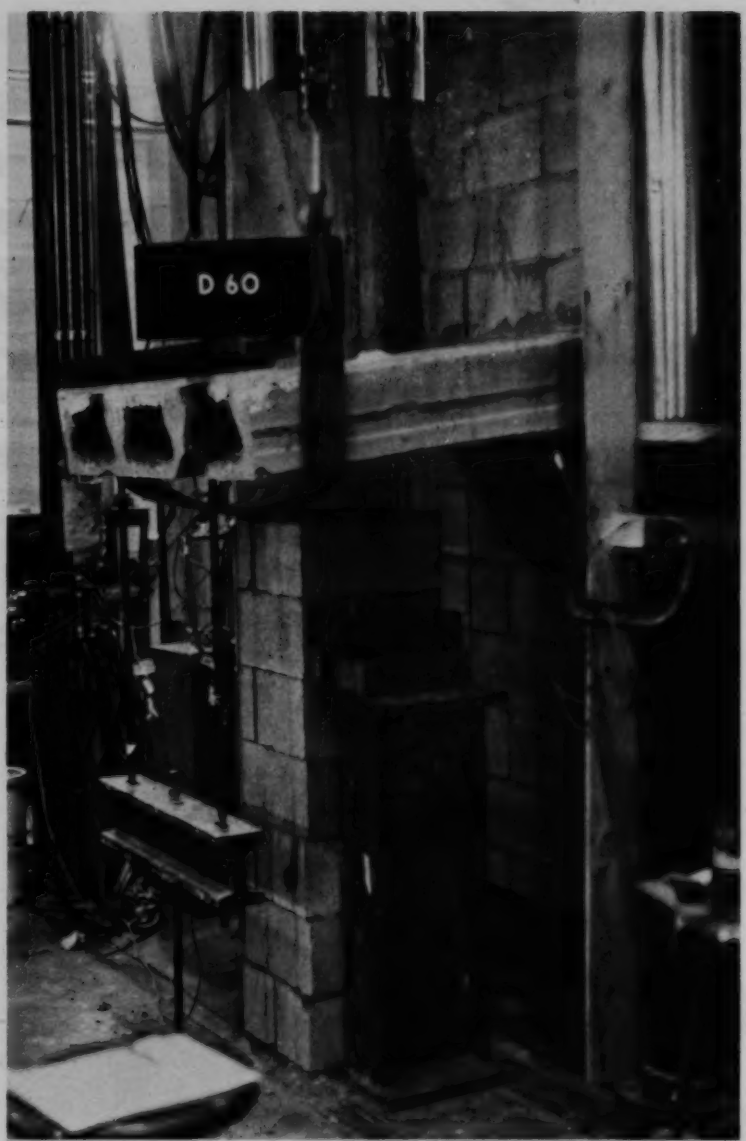
Plate 4.4 Wall D60 At Failure

The moment versus slab rotation relationships for all of the specimens with precast slabs are summarized in both tabular and graphic form in Appendix A. A photograph of wall D60, having a joint reinforced with wrap-around bars and two foot long vertical bars, at failure is presented in

A large slab deflection occurred as soon as the slab supports were removed. As Mmax was reached a vertical crack opened at the precast slab end and a horizontal crack appeared along the mortar joint at the top of the slab. The deflection of the slab was increased and the joint was able to resist some moment. This continued until the tops of the vertical bars began pushing through the face of the wall.

Next, the slab was lifted to its original position and the axial load on the wall was increased. The wall failed, under an axial load of 140 kips, by crushing and spalling of the blocks where the vertical bars had been pushing through.
